Forensic Building Science, Inc.

Causation, Scope of Repair and Code Submission

Property: Knights Inn at 1121 9th Ave. SW, Bessemer, AL 35022

Storm Damage Report

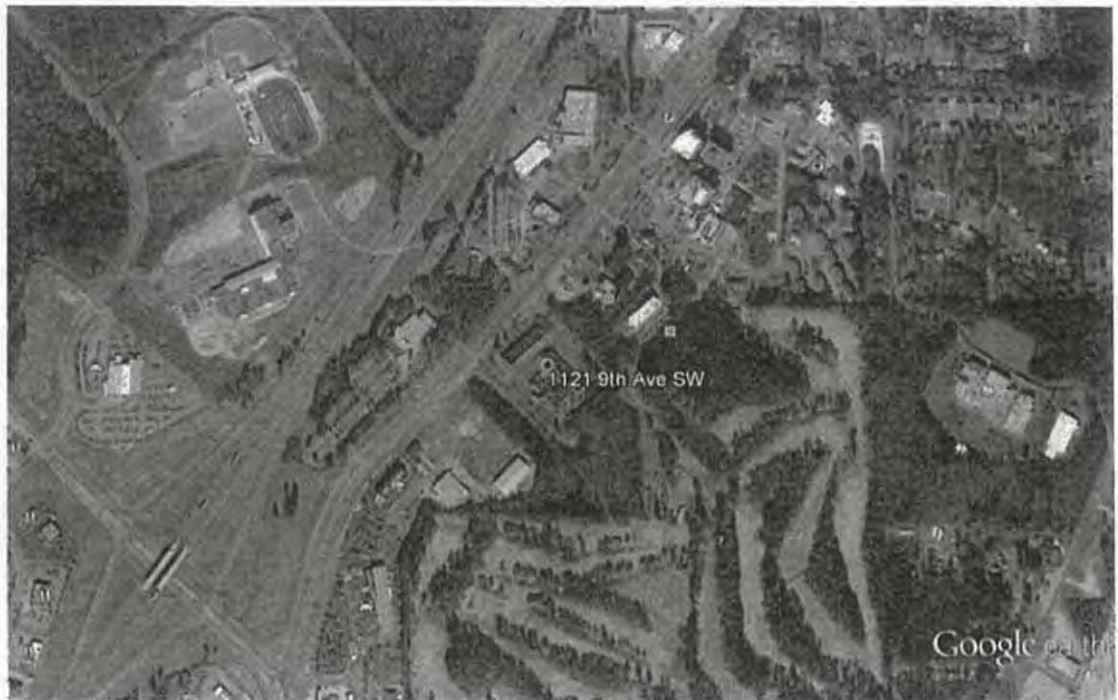
Google Earth, Imagery Date 12/17/2013 (before storm), approx. 2,600 ft radius.

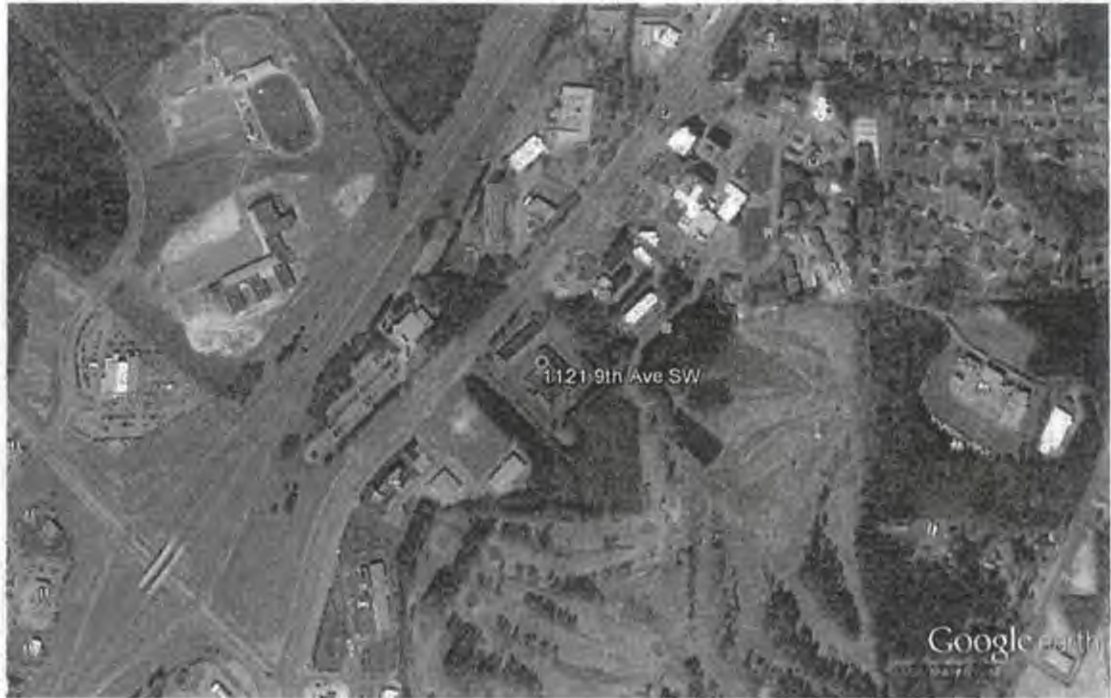
Google Earth Imagery Date 2/6/2015 – large areas of trees to east and south gone.

- Area is surrounded by open space and sparse low-rise commercial buildings which is inconsistent with the definition of Exposure B in ASCE 7, Exposure C applies.

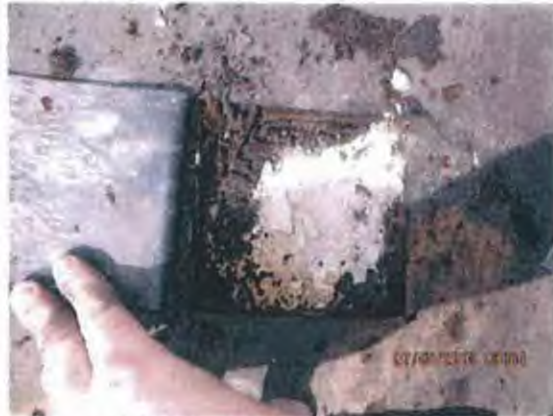
Core Cut #1:

- Located 15' from east wall and 20' from north wall.
- 60 millimeter EPDM single ply membrane. (Figure 46)
- 1/2" of actively wet fiberboard. (Figure 79)
- previous roof membranes left in place, \approx 3 (Figure 82).
- 2" of LWIC.
- Corrugated roof deck.

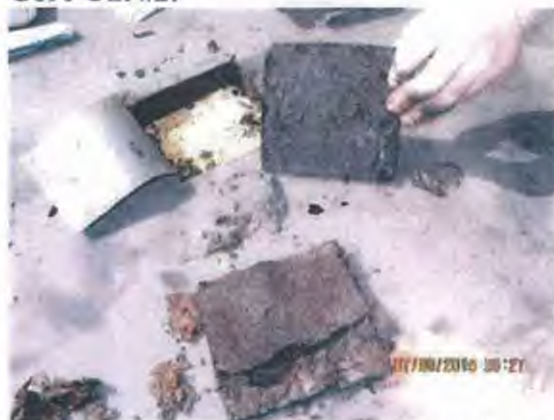
Core Cut #2:

- Located 16' from west wall and 51' from south wall.
- 60 millimeter EPDM single ply membrane.
- visually ½" of actively wet fiberboard cover board, saturated (Figure 92).
- previous roof membranes left in place, ≈ 3 (Figure 98).
- Tan cementitious material, visually LWIC, wet (Figure 99).

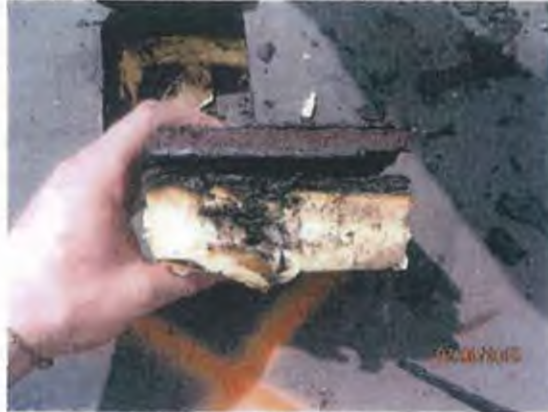
Core Cut #1:

- Located 8' from south wall and 10' from west wall.
- EPDM with active water (Figure 38).
- 1/2" of saturated fiberboard (Figure 39).
- previous roof membranes left in place, ≈ 3 (Figure 44).
- 2" of wet foam insulation (Figure 44).
- 2" Lightweight insulating concrete (LWIC).
- Corrugated metal roof deck.

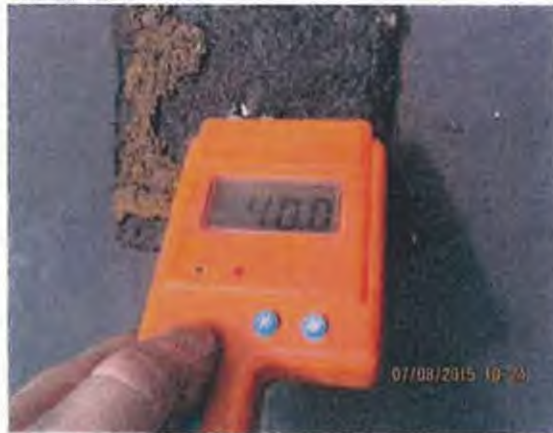
Core Cut #2:

- Located 3' from south wall and 10' from west wall.
- Fiberboard peeled off with membrane (Figure 63).
- Fiberboard saturated (Figure 67).
- Previous roof membranes, ≈ 3 (Figure 69).
- 2" wet foam insulation – visually isocyanurate rigid foam board. (Figure 69).
- Wet LWIC substrate (Figure 71).

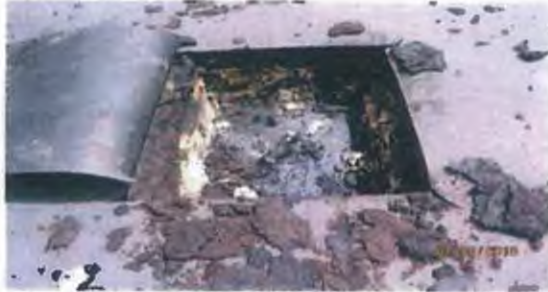
Core Cut #1:

- Located 4' from west expansion and 4' from north wall.
- Active water on underside of EPDM (Figure 41).
- 1/2" of saturated and friable fiberboard (Figure 42).
- previous roof membrane, \approx 3 (Figure 49).
- 2" of foam insulation (Figure 45).
- 2" of actively wet LWIC (Figure 48).
- Corrugated metal roof deck.

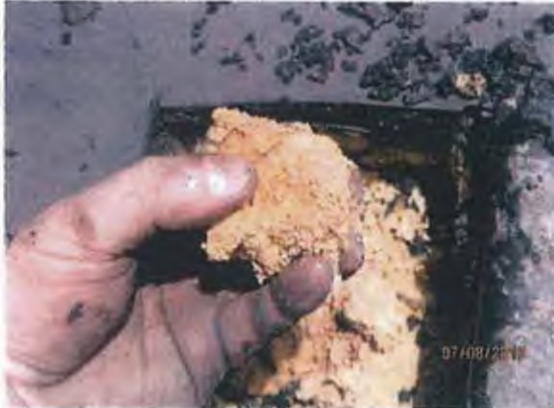
Core Cut 2:

- Located 3' from the south wall and 10' from the west wall.
- Active water underneath EPDM (Figure 61).
- Saturated fiberboard (Figure 65).
- Wet rigid insulation (Figure 67).
- Base sheet (Figure 68).
- Friable and wet cementitious material (LWIC) (Figures 70-72).
- Corrugated metal deck.
